INVESTIGATION OF THE HOOD EFFECT
OF THE 6" COMM. MK. 27-7 PROJECTILE
AT VARIOUS OBLIQUITIES

Naval Proving Ground
Dahlgren, Virginia

21 April 1947

No. 1238-47

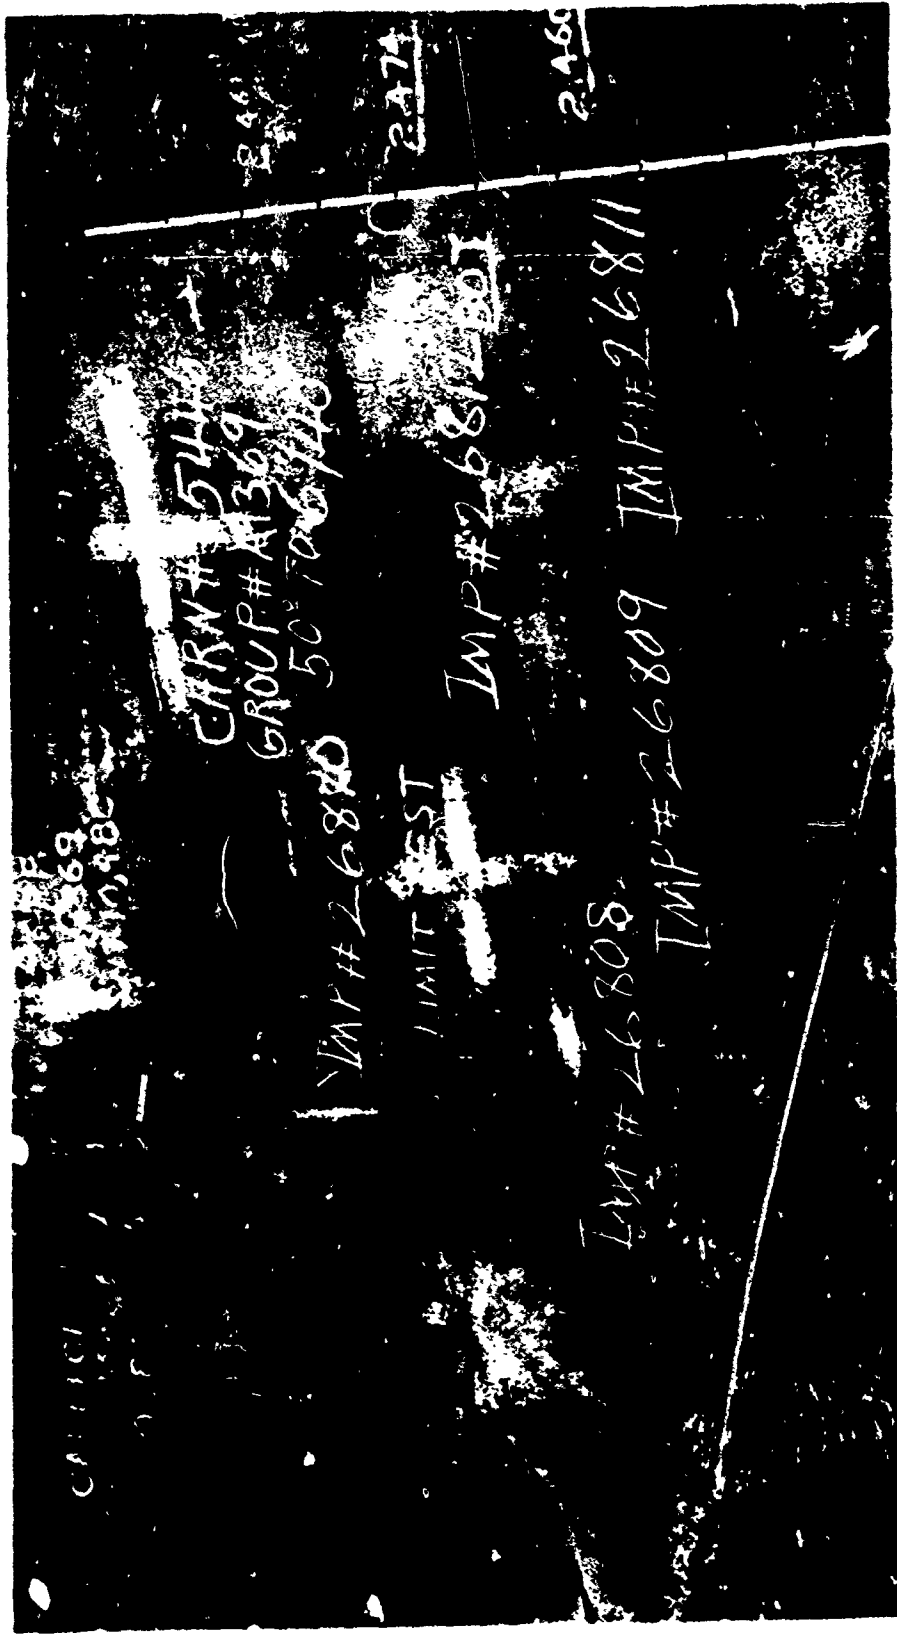
Imp 34254 - Imp. Limit Test of 2.45" 270 Plate No. 75446 vs. by Carnerie
 with steel 20. vs. 20" Corp. No. 2727 Proj. Imp with and without
 windshield and hood. View: front of Plate.

Impact	Cbl.	J.V.	2 Sk. 74241	Fene.	Thru Open	Projectile
26202	50°30'	1339	103.7	1-5/8"	None	with windshield and hood
26209	49°20'	1442	107.9	Corp.	8" x 5"	"
26210	50°10'	1405	105.3	3"	6" x 1 1/2"	"
26211	48°40'	1339	95.3	3"	6" x 3/8"	Without windshield and hood
26212	49°30'	1325	95.1	Corp.	6" x 9"	"

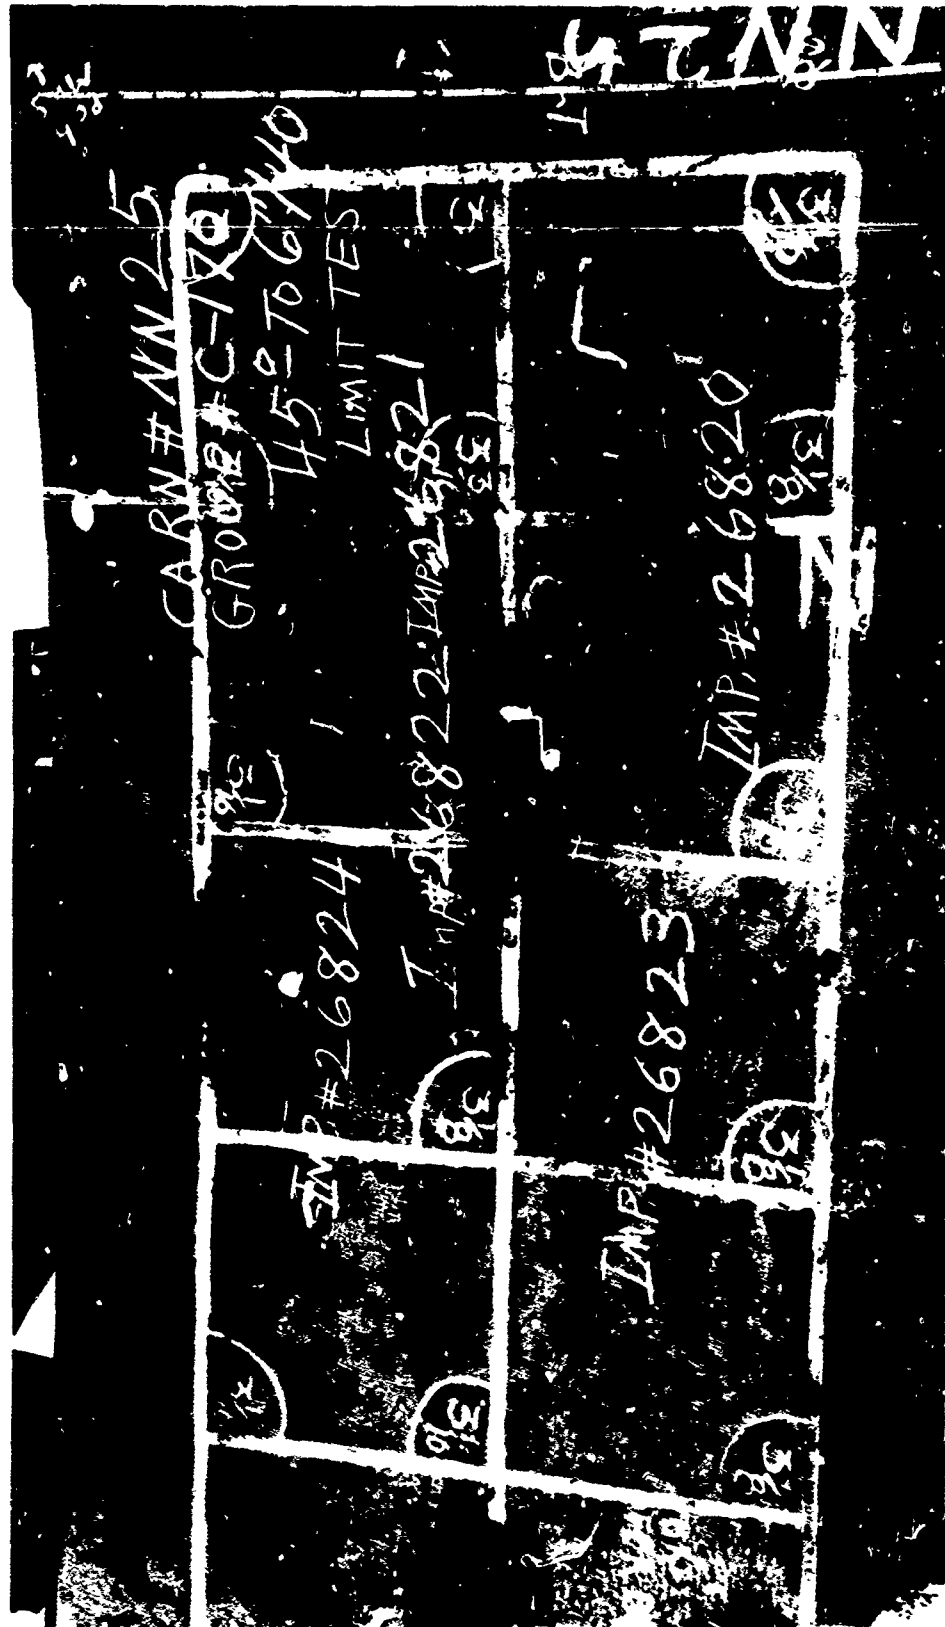
NR9 34055 - Bal. Limit Test of 3"13 STS Plate No. NN-25 Mfd. by Carnegie
 Illinois Steel Co. vs. 6" Corron Pk. 27-7 Proj. IL&P with and without
 windshield and hood. View: Front of Plate.

Impact	Cbl.	S.V.	W. 34. 78471	None.	Thru Open	Projectile
25220	45°00'	1438	97.6	2-3/4"	None	with windshield and hood
25221	45°40'	1507	100.5	2-1/4"	None	"
25222	45°30'	1543	105.7	3" P.	6" x 7"	"
25223	44°20'	1413	92.3	2-1/2"	None	without windshield and hood
25224	45°00'	1421	97.4	Comp.	6" x 7"	"

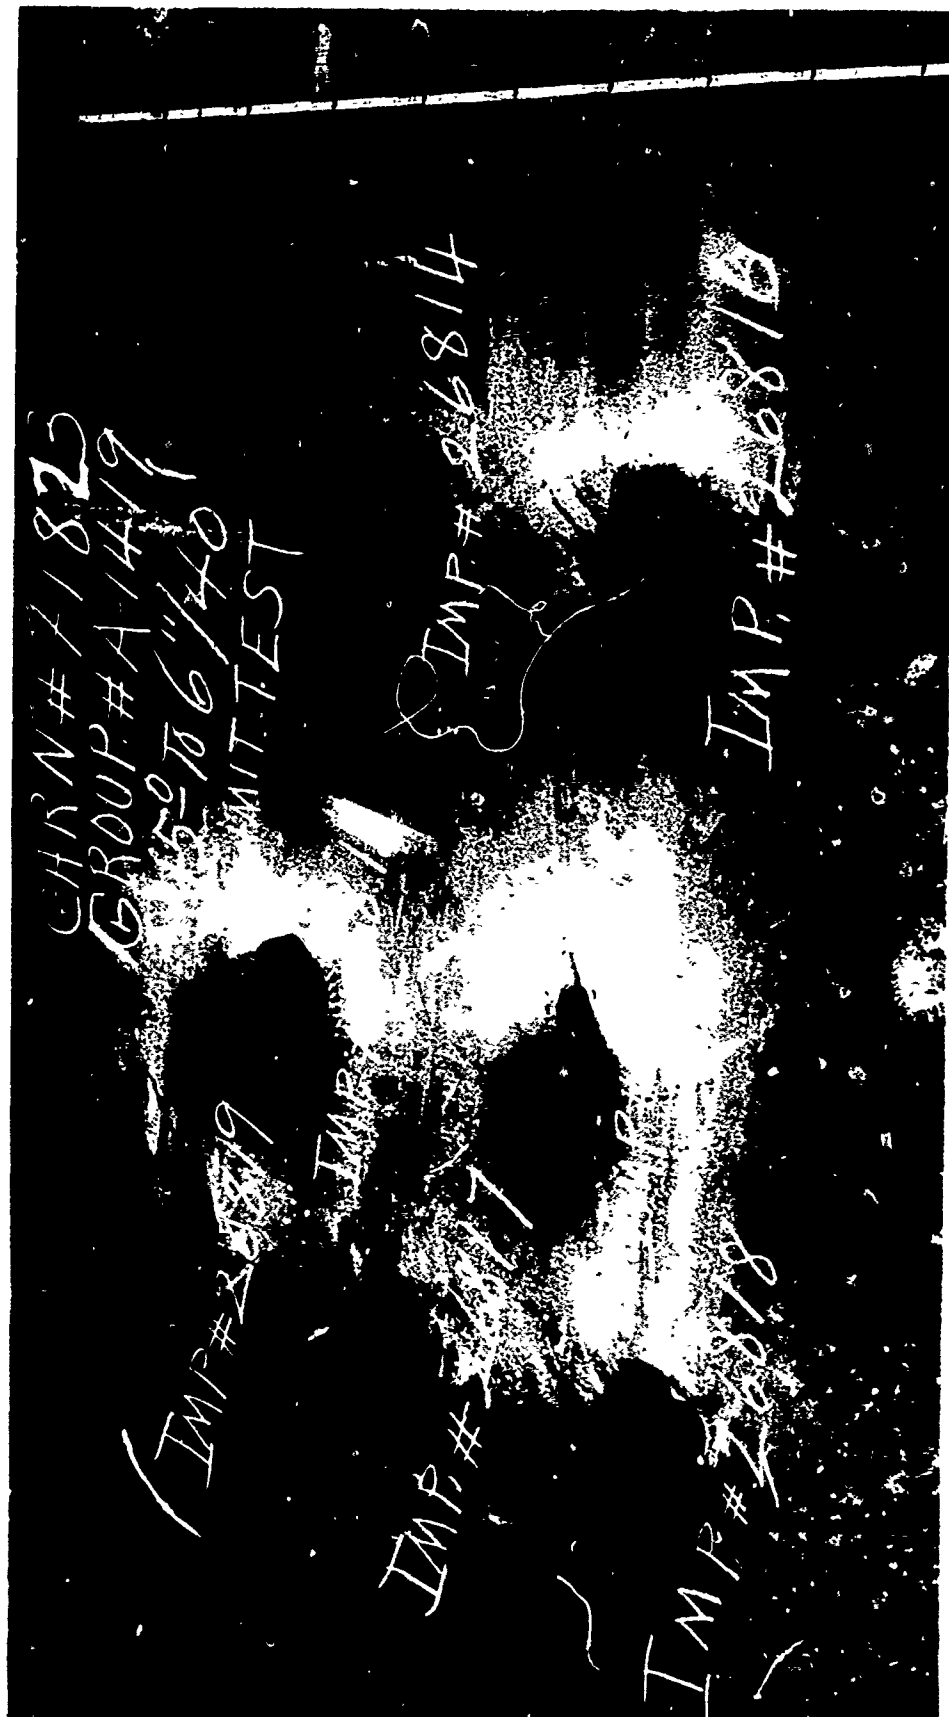
229 3560 - Cal. Fire of 1945, Plate No. F-1223 Mfd. by Carnegie Illinois
Steel Co. 31.3" Corron 12.27-7 Projectiles IMP with and without windshield
and hood. View: Front of Plate.

Image	Cbl.	I.V.	% Sk.	724.1	Pene.	Thru Open	Projectile
26813	45°10'	256		95.3	Comp.	6" x 7"	without windshield and hood
26814	45°00'	233		87.4	Comp.	6" x 6-1/4"	" " "
26815	45°00'	716		78.7	1-1/2"	1/2" x 5-1/2"	" " "
26816	45°40'	746		82.9	3"	6-1/2" x 4-1/2"	" " "
26817	44°40'	297		109.0	Comp.	6" x 7"	With windshield and hood
26818	44°00'	254		103.8	Comp.	6" x 7"	" " "
26819	44°00'	795		96.6	3"	3-1/2" x 8"	" " "

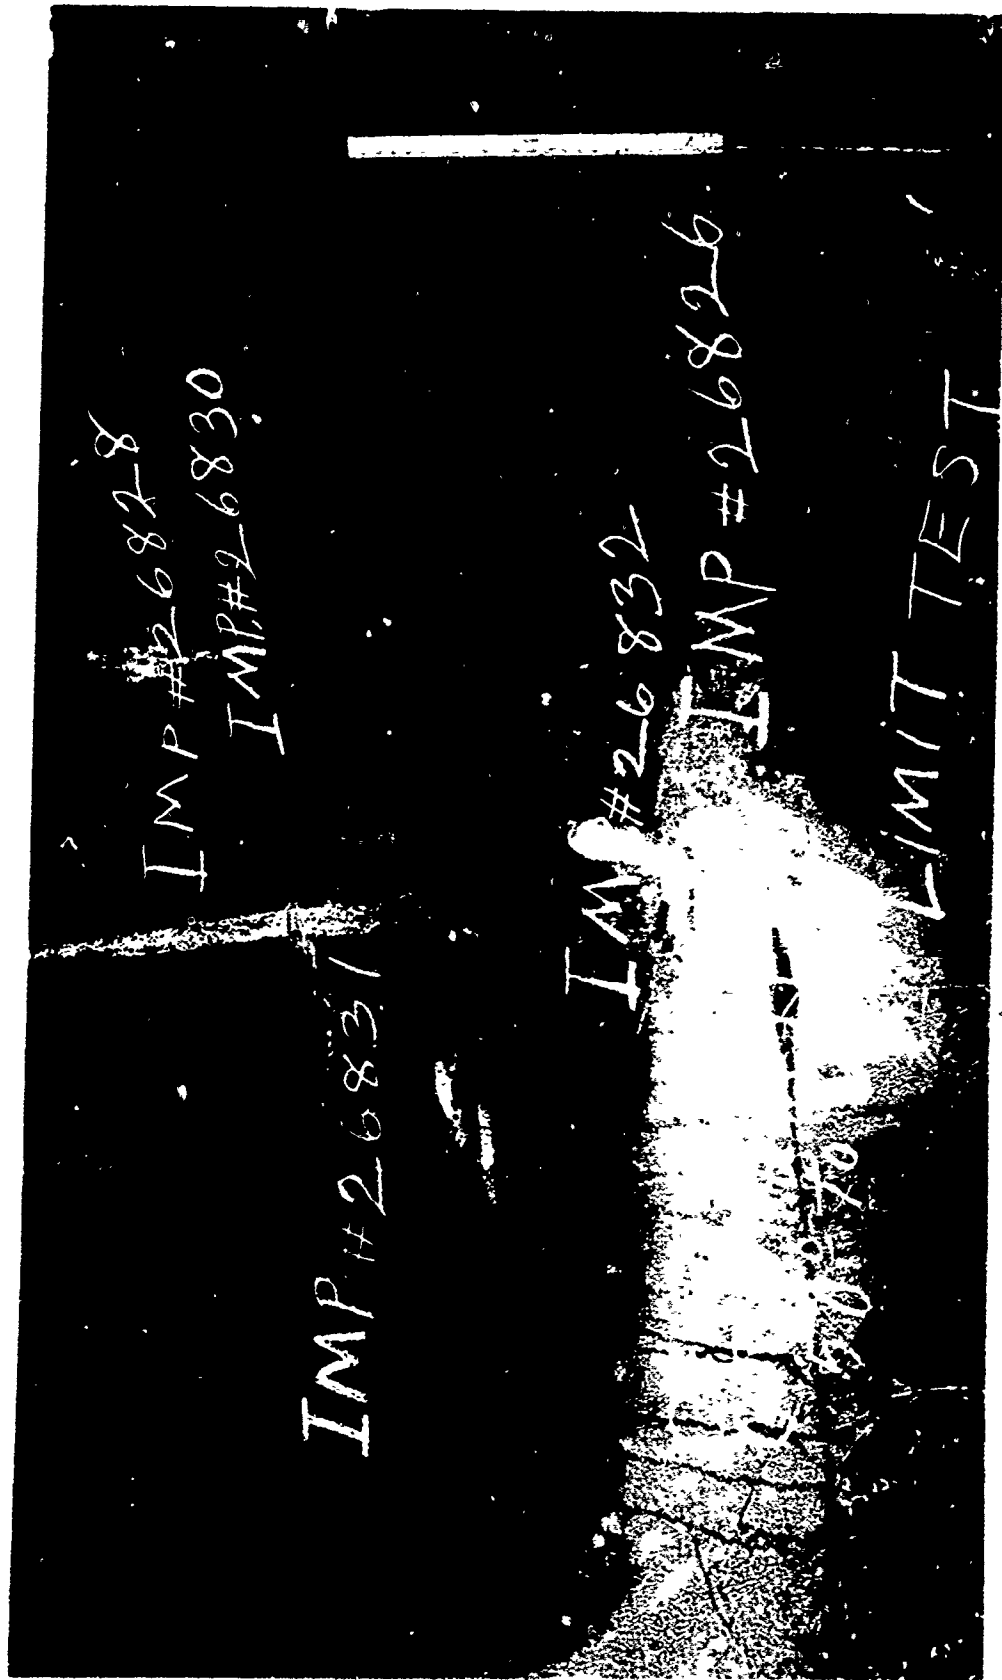
STO 35062 - Bal. Limit Test of C-97 ST3 Plate No. 634580 Mfd. by Carnegie Illinois Steel Co. vs. 6" Carron Pk. 27-7 Proj. IL&P with and without windshield and hood. View: Front of plate.

<u>Irract</u>	<u>Obl.</u>	<u>S.V.</u>	<u>% Sk. 78841</u>	<u>Pene.</u>	<u>Thru Open</u>	<u>Projectile</u>
20820	50°50'	724	101.7	Comp.	6" x 17"	With windshield and hood
20828	51°00'	695	96.8	5/8"	None	"
20830	50°00'	662	89.3	Comp.	6" x 8"	Without windshield and hood
20831	50°00'	597	80.7	1-1/4"	3/4" x 10"	"
20832	51°00'	628	84.0	Comp.	6" x 11"	"

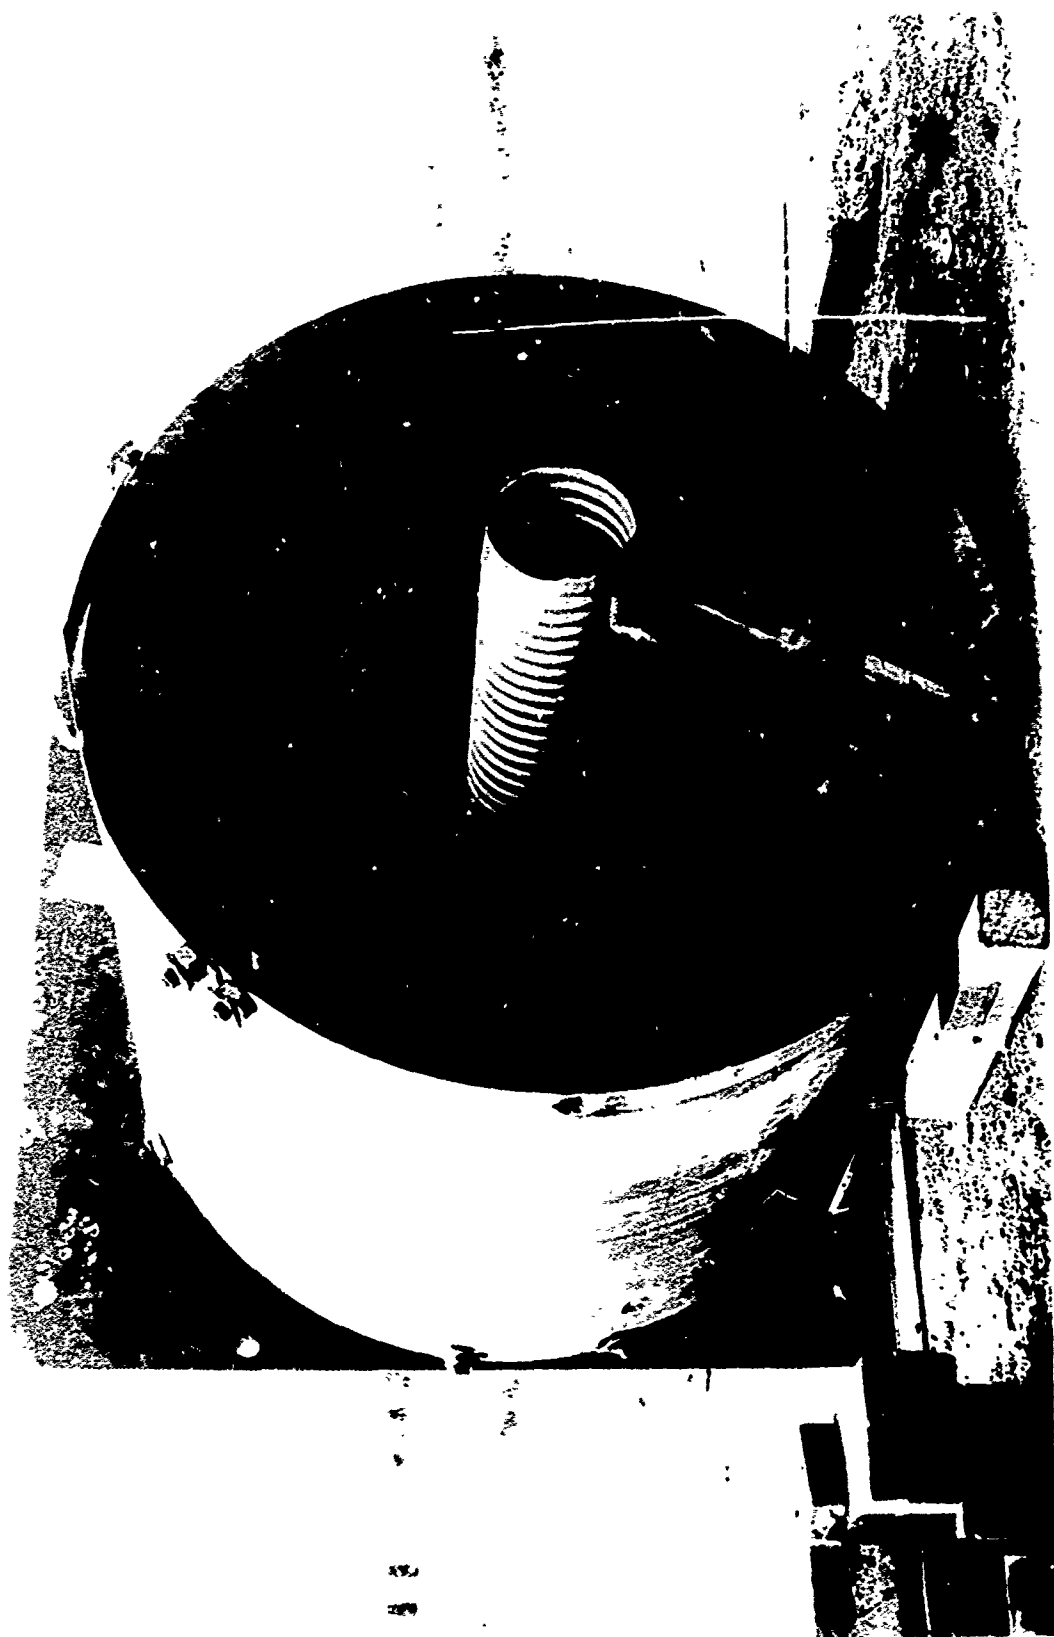
2. One projectile in the subject tests was fired at 0° obliquity versus a plate of STS with an arrangement for capturing the fragments of the hood and windshield. The arrangement is shown in the photos. of Enclosure (A). The parts consisted of a nine foot armor tube, an eighteen inch culvert pipe, and two cover plates with round holes large enough to admit the culvert pipe. The annular space between the culvert pipe and the armor tube was filled with sawdust, the annular space was covered, and the assembled apparatus was placed against the target plate. The projectile traveled a distance of 10 feet down the culvert pipe to the point of impact.

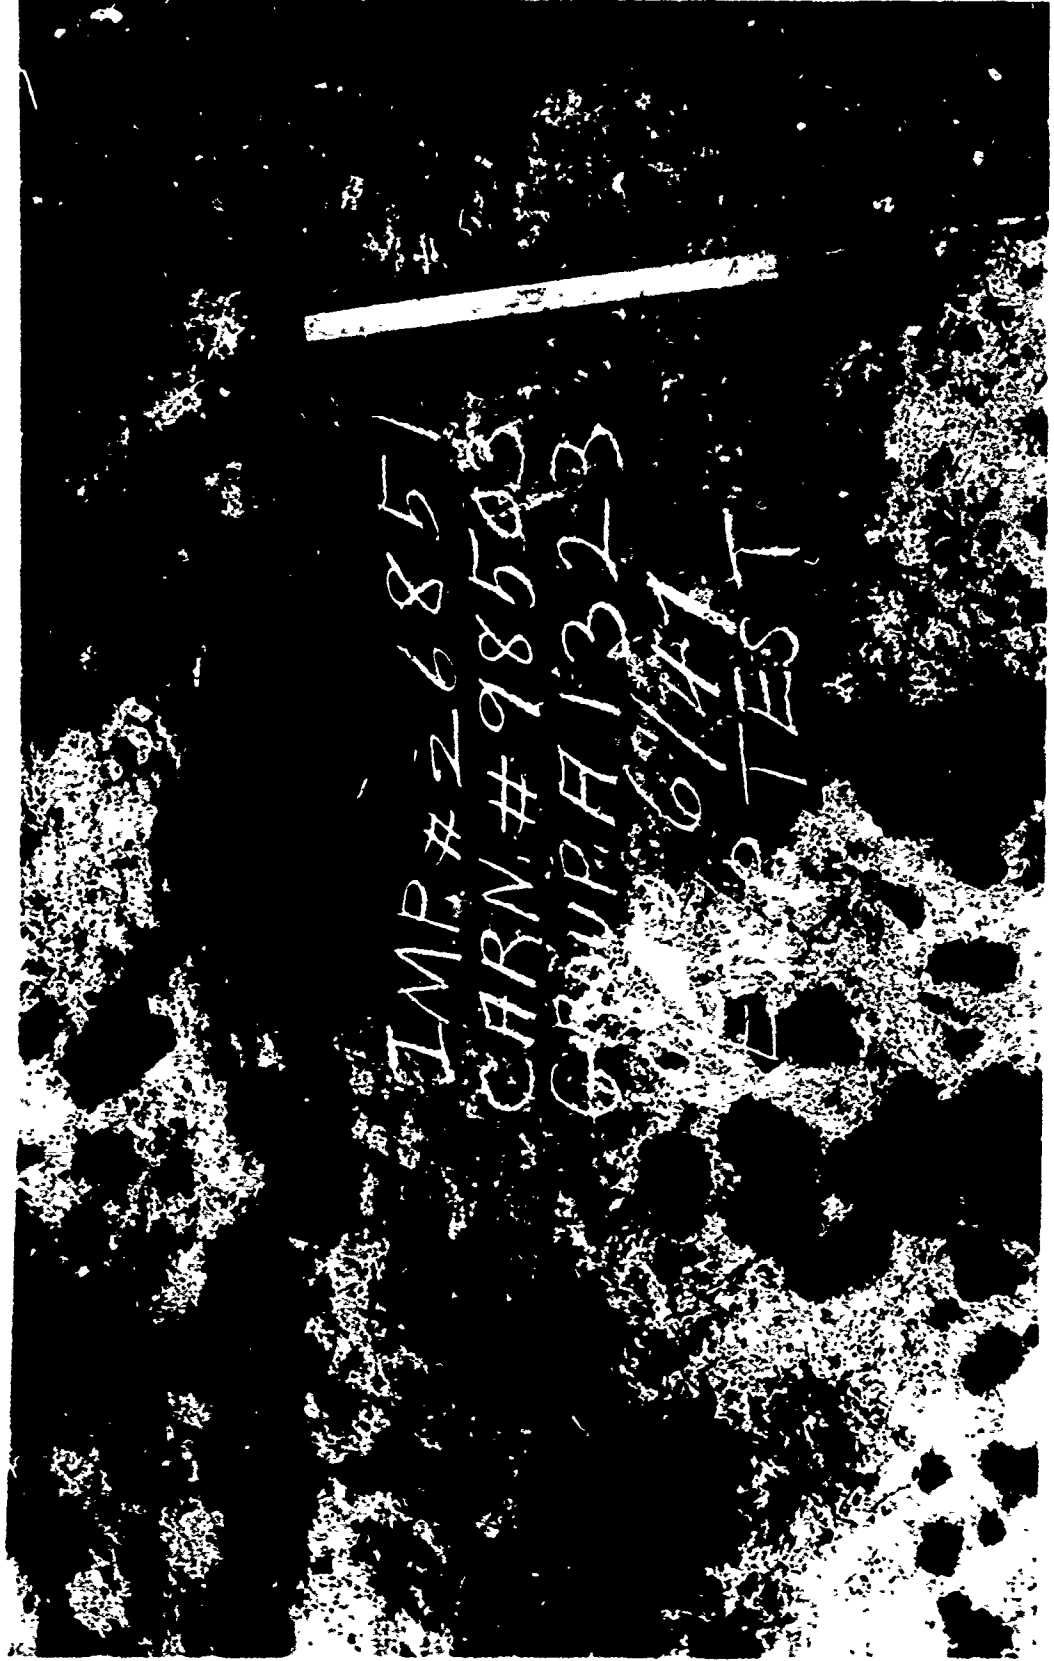
NP9 34056 - Bal. Exp. Test of 17908 ST3 Plate No. 98503 Mfd. by Carnegie
Illinois Steel Corp. vs. 6" Common Mk. 27-7 Proj. IL&P fired for recovery of
fragments of the windshield and hood. View: Front of Plate.

26851 0° 957 127.9 Comp. 6-3/4" x 7"

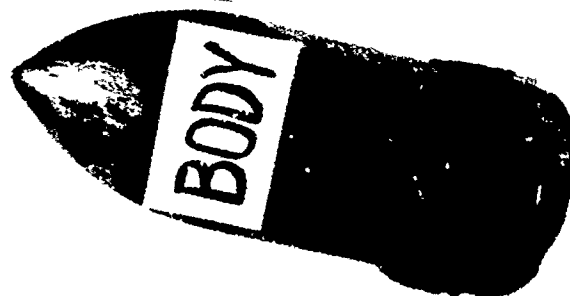
179 34290 - Ballistic XI, bit of 1.90" 37" of the
 by Jarnegie-Ilinois Steel Corp. vs. W. J. Jarnegie-Ilinois
 steel and lead - view of recovered fragments.

The fragments were recovered without evidence of any secondary damage. The windshield and the crown of the hood were splintered into many small pieces, but the skirt of the hood was recovered in three equal pieces. The crown of the hood appeared to have fractured by shear after severe plastic deformation, as illustrated by lamellar blocks of the metal which have slipped over each other without becoming separated. The skirt of the hood experienced several brittle fractures on planes normal to the prevailing axis of tension in the region free from severe cold work, but each normal fracture shifted to the shear type of fracture when it ran into the severely worked region. Three of these brittle fractures were initiated by three minute punched indentations on the shoulder of the

hood, but a fourth crack was also observed which did not originate from any obvious imperfection. The fourth crack did not pass into the plastically deformed region, as revealed by microsections of the recovered fragment. The fourth crack probably failed to reach completion because of a release of stress by the prior completion of the other three fractures. Measurements of the fragments show that the reduction of area at the brittle fractures was not more than 2%, whereas the material of the hood would undergo a reduction of area of more than 65% in a standard tensile test. The full elongation was, in fact, obtained in the region of severe plastic deformation.

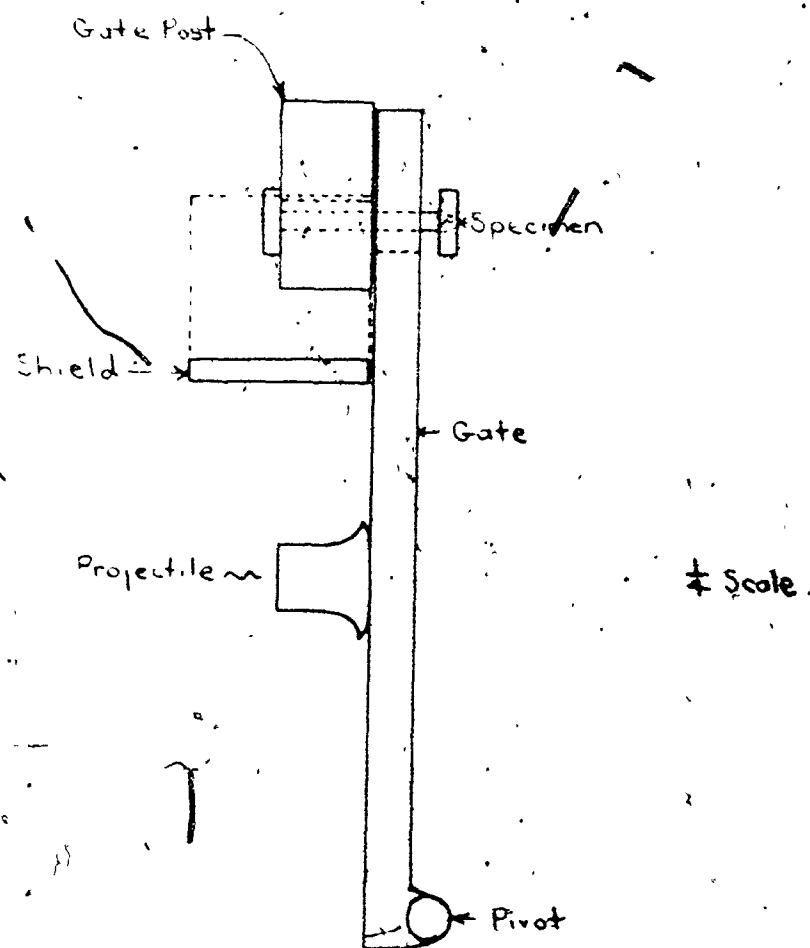
SCHEMATIC DIAGRAM OF APPARATUS FOR SHOCK
LOADING OF TENSILE SPECIMENS.

To test this hypothesis, apparatus was constructed at the Light Armor Battery. The apparatus consisted of a gate, which was made of BPS plate 1" thick by 7" high by 18" wide. The gate was pivoted at one side where it bore against a gate post. The gate and gate post at the other side were notched to receive a special tensile specimen 3/8" diameter by 3.5" gage length. A shield was mounted over the specimen to protect it from fragments. Clearance was arranged between the head of the tensile specimen and the gate, so that the gate would have time to pick up speed before impact on the specimen. The specimen was carefully aligned with the face of the gate, so that the impact between gate and specimen would be as sudden as possible.

The first specimen was machined from a 37mm T21 mild steel projectile. Another 37mm T21 projectile was fired at the center of the gate with a striking velocity of the order of 700 (ft.)/(sec.). The specimen was necked down and not broken.

The second specimen was machined from a piece of annealed mild steel bar stock with a BHN of 120. A 37mm T21 projectile was fired at the gate with a striking velocity of the order of 1800 (ft.)/(sec.). The gate was broken in half at the point of impact, and the projectile was derolished from the nose to the rotating band. The gate was also broken at the point where it came into contact with the head of the specimen. The specimen itself was necked down to fracture with the full reduction of area in a

Although the gate was a casualty in the above test, it is nevertheless possible to estimate the minimum velocity with which the gate must have struck the head of the specimen. The work required to break the specimen can be estimated from its known tensile strength and its measured dimensions. This energy was necessarily available in the piece of gate which struck the specimen.* The specimen was elongated .9" and the work of deformation is estimated to have been 630 (ft.)(lb.). The piece of gate weighed 16 (lb.), and its velocity is therefore estimated to have been at least 80 (ft.)/(sec.). While stretching the specimen the piece of gate turned through an angle of 13°.
